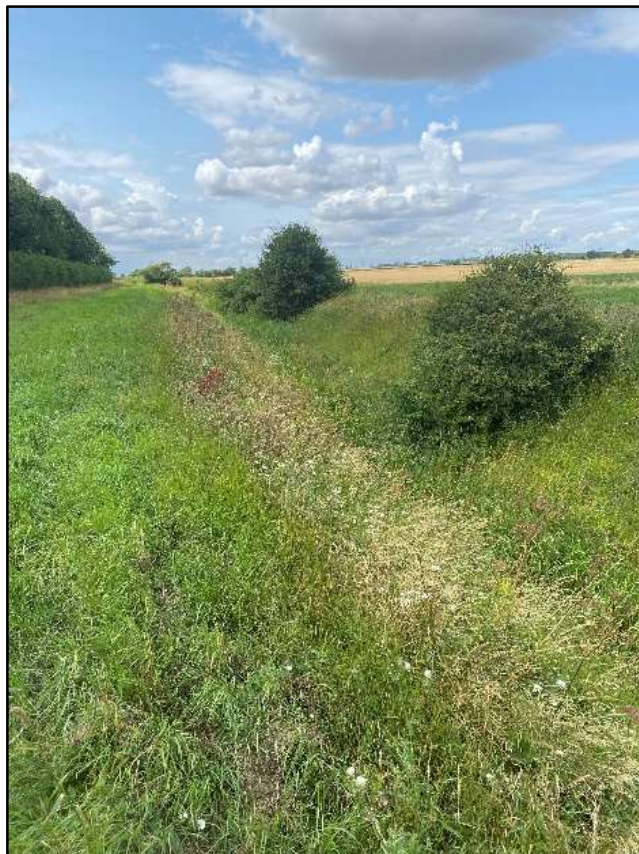
**Location:** 1

**Description:** Hodge Dike, with overgrown vegetation throughout bank, left bank c.2m, right bank c.2m, width c.5m, depth c.0.3m facing West

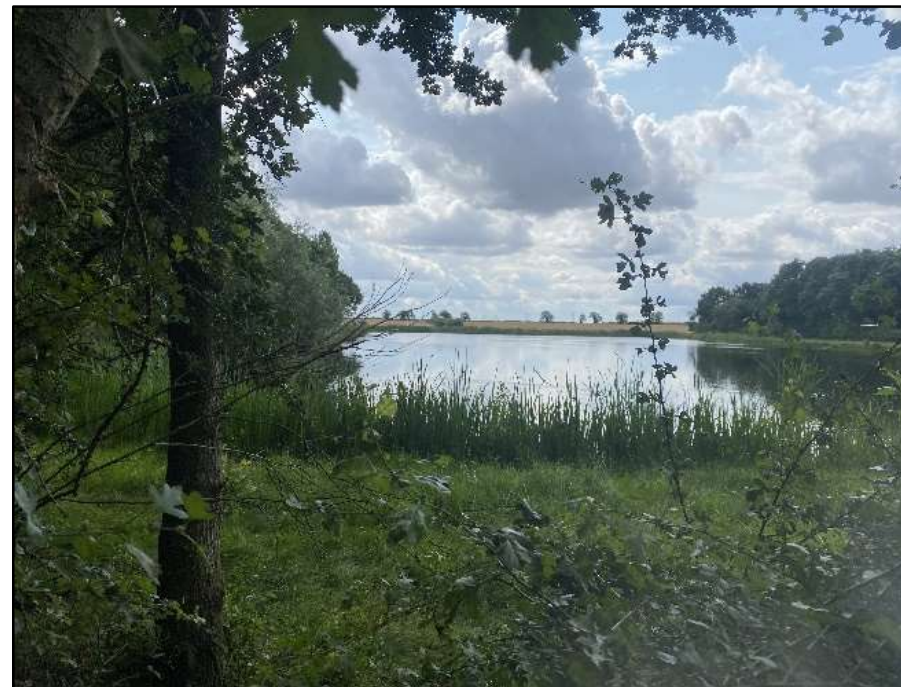
**Location:** 2

**Description:** Unnamed reservoir, facing south.

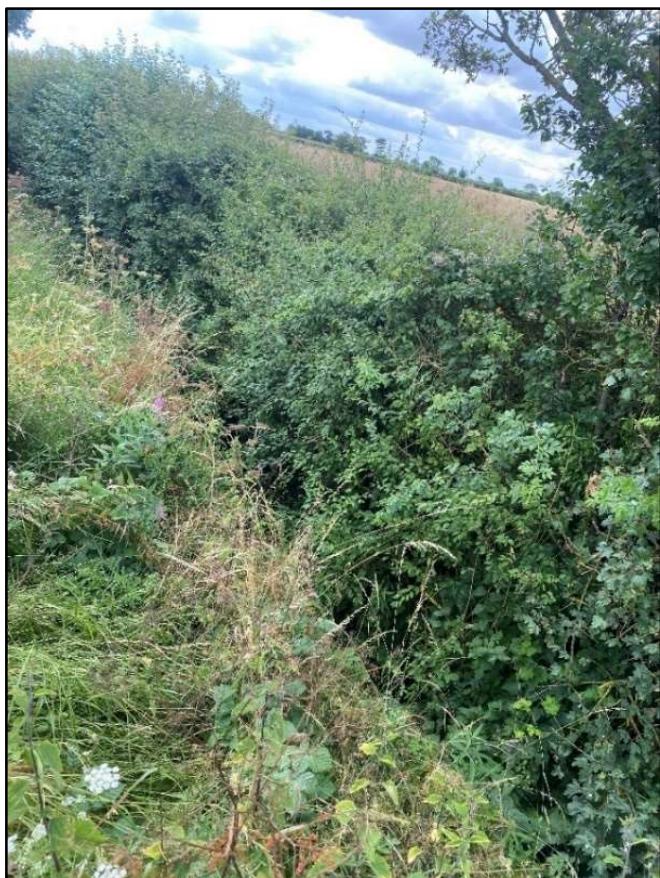
**Location:** 3

**Description:** Unnamed drain, with overgrown vegetation throughout bank, left bank c.1m, right bank c.1m, width c.1.5m. Facing south

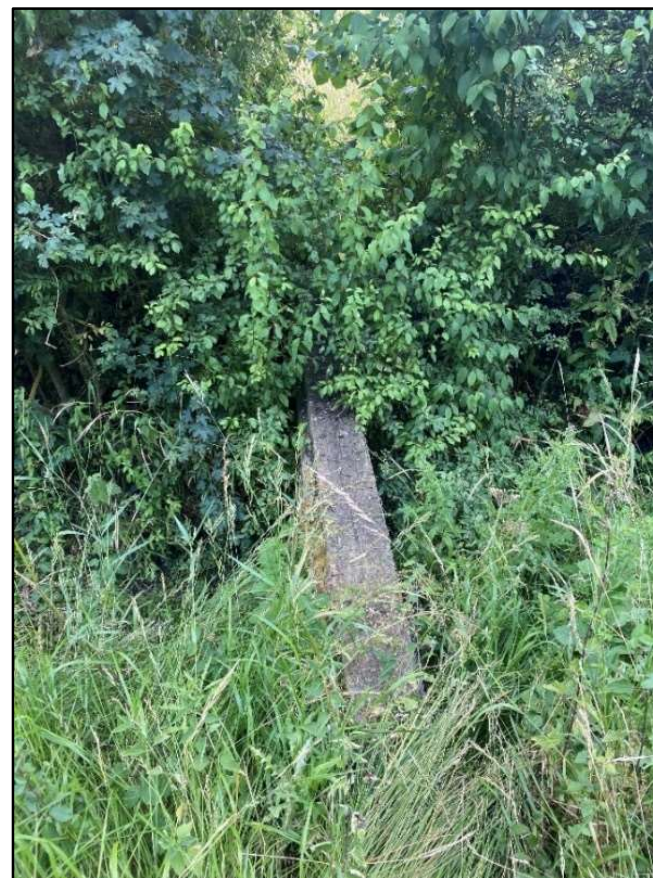
**Location:** 4

**Description:** Footbridge. Facing West

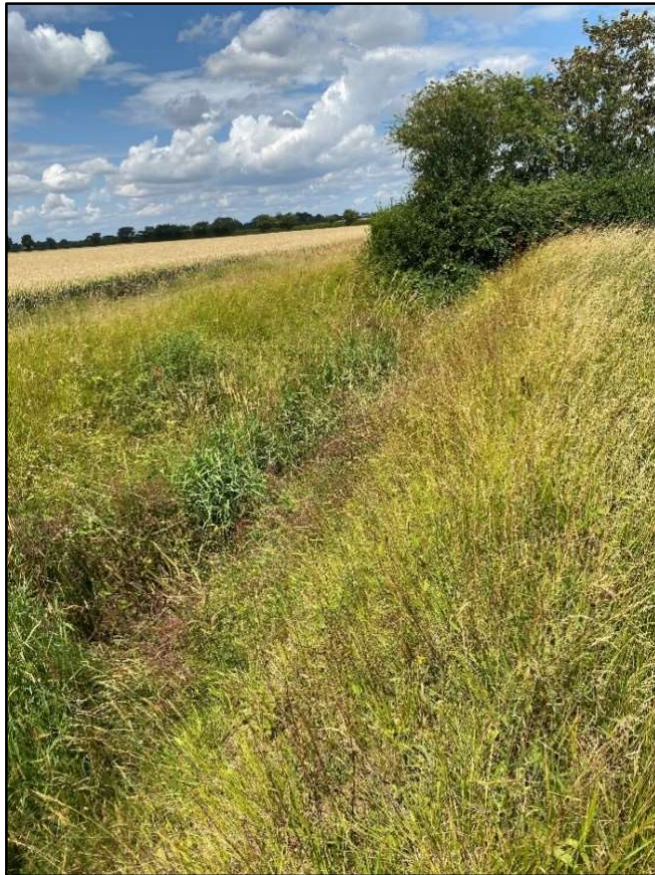
**Location:** 5

**Description:** Unnamed drain, with overgrown vegetation throughout channel, left bank c.1.5m, right bank c.1.5m, width c.2m. Facing northwest

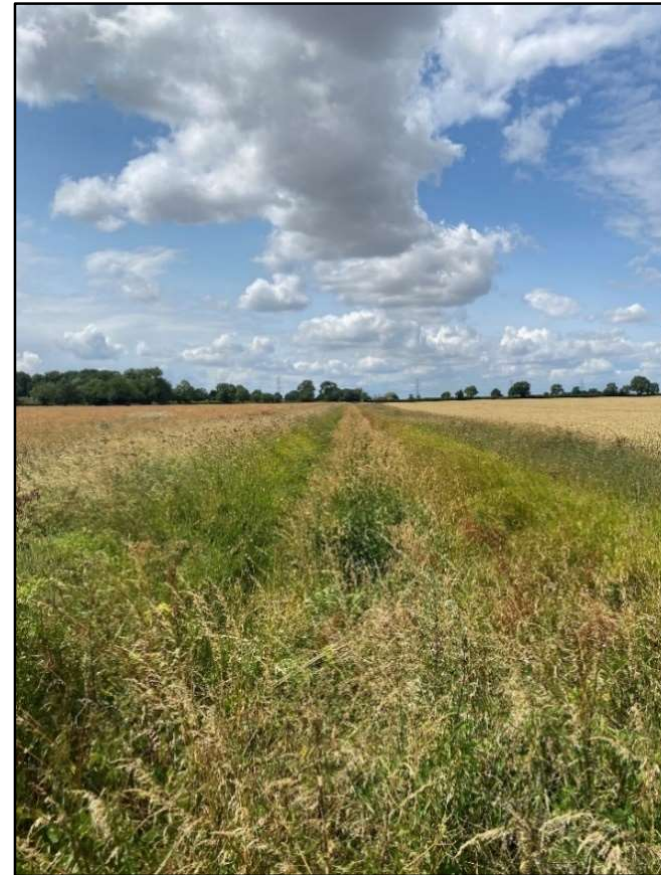
**Location:** 6

**Description:** Unnamed drain (dry), with overgrown vegetation throughout channel, left bank c.1.5m, right bank c.1.5m, width c.2m. Facing west

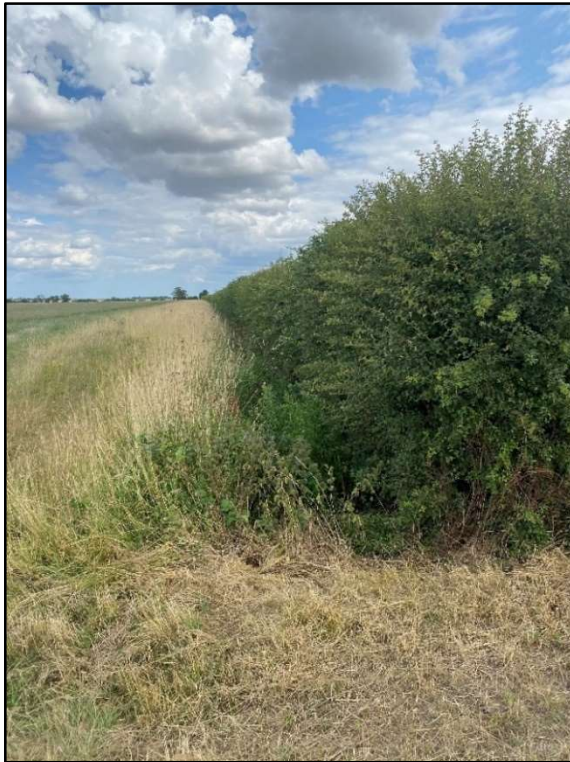
**Location:** 7

**Description:** North side of unnamed drain, with a hedge and overgrown vegetation throughout channel, left bank c.1.5m, right bank c.1.5m, width c.2m. Facing east.

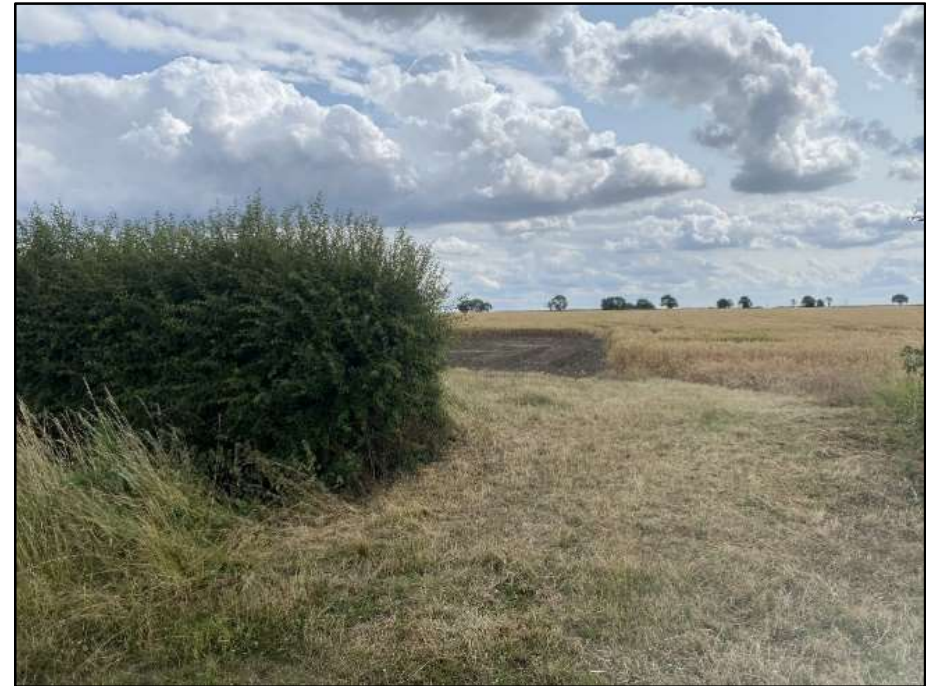
**Location:** 8

**Description:** Same unnamed drain as 7. Passing place. Facing southeast.

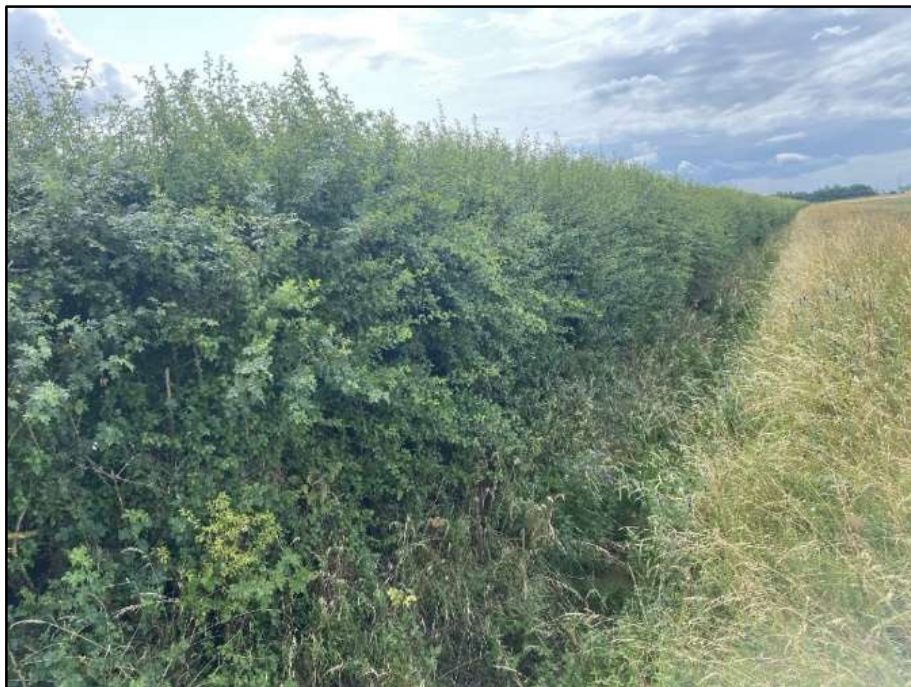
**Location:** 9

**Description:** South side of unnamed drain, with a hedge and overgrown vegetation throughout channel, left bank c.1.5m, right bank c.1.5m, width c.2m. Facing east.

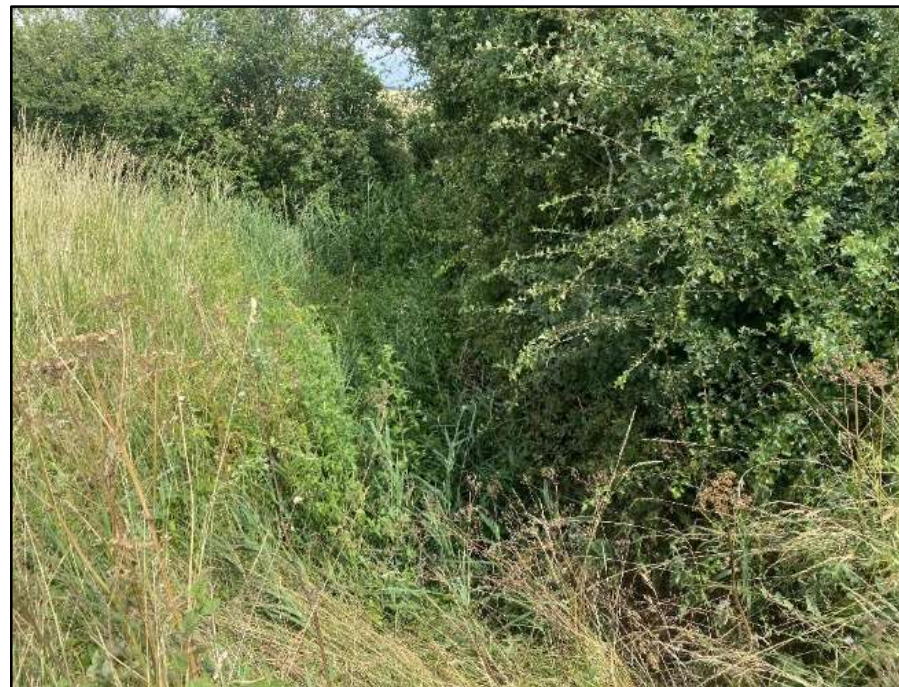
**Location:** 10

**Description:** Unnamed drain, with a hedge and overgrown vegetation throughout channel, left bank c.1.5m, right bank c.1.5m, width c.2m. Facing east.

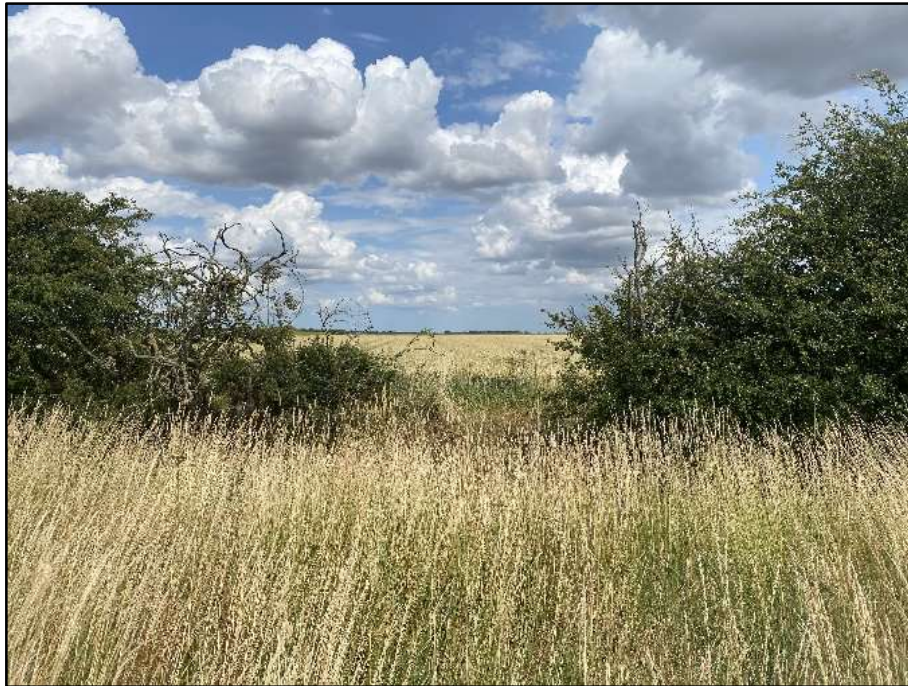
**Location:** 11  
**NGR:** TF 15190 47698  
**Photo Date:** 13 July 2023  
**Description:** Unnamed drain, with a hedge and overgrown vegetation throughout channel, left bank c.1.5m, right bank c.1.5m, width c.2m. Facing east.

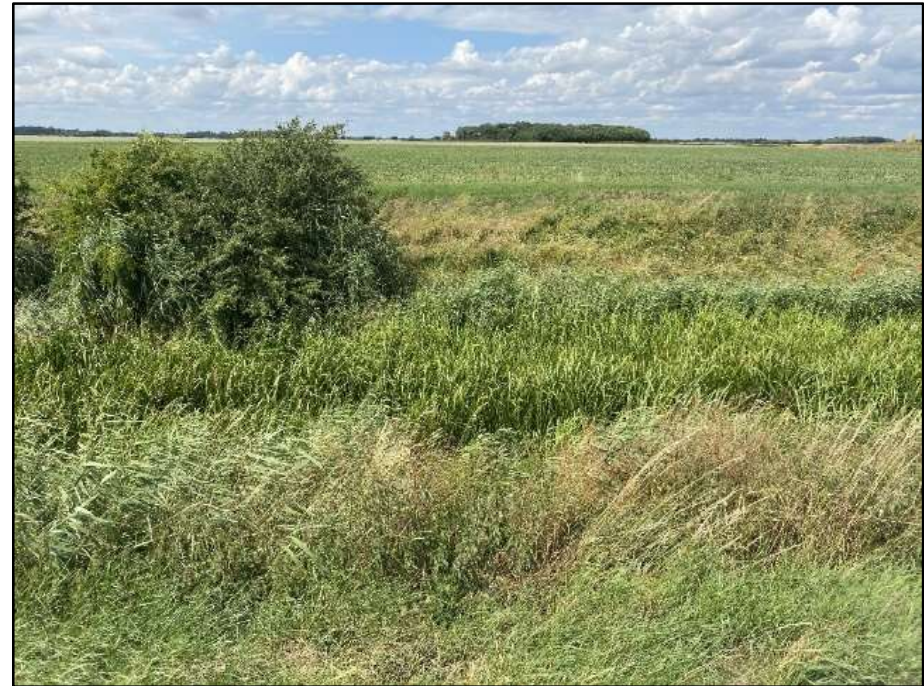
**Location:** 12  
**NGR:** TF 15111 47772  
**Photo Date:** 13 July 2023  
**Description:** Hodge Dike, overgrown vegetation throughout channel, left bank c.2m, right bank c.2m, width c.5m, channel c.0.3m. Facing north.

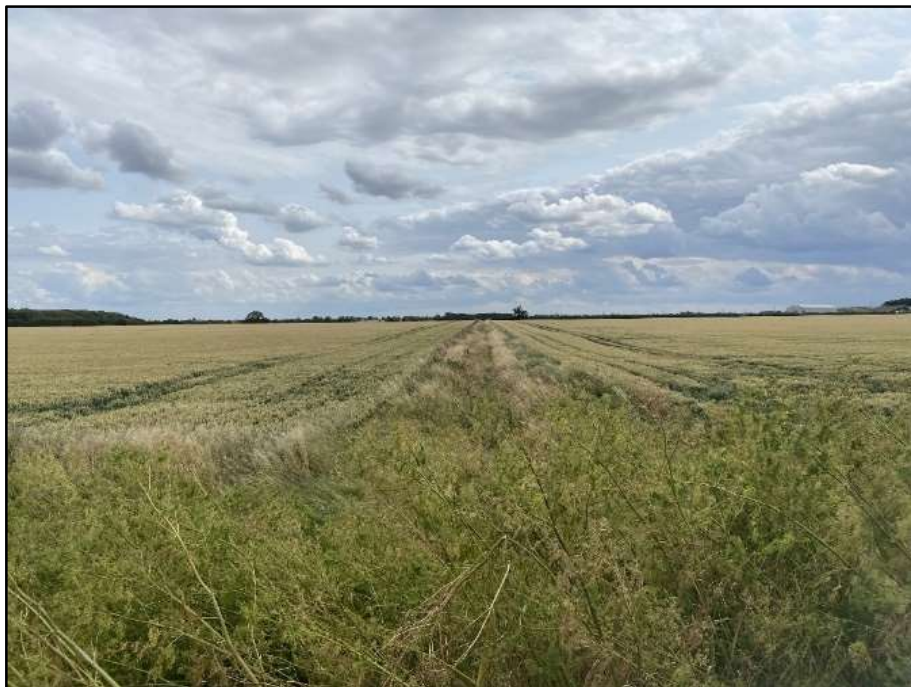
**Location:** 13  
**NGR:** TF 15512 48030  
**Photo Date:** 13 July 2023  
**Description:** Unnamed drain, with overgrown vegetation throughout channel, left bank c.1.5m, right bank c.1.5m, width c.2m. Facing south.

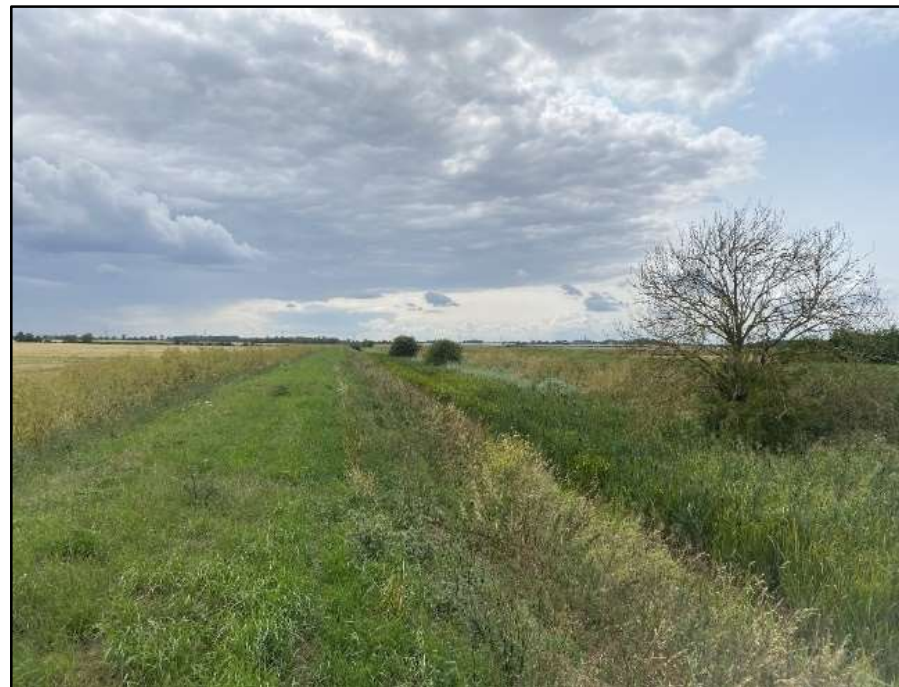
**Location:** 14  
**NGR:** TF 15817 48268  
**Photo Date:** 13 July 2023  
**Description:** Unnamed drain, with overgrown vegetation throughout channel, left bank c.1.5m, right bank c.1.5m, width c.2m. Facing west.

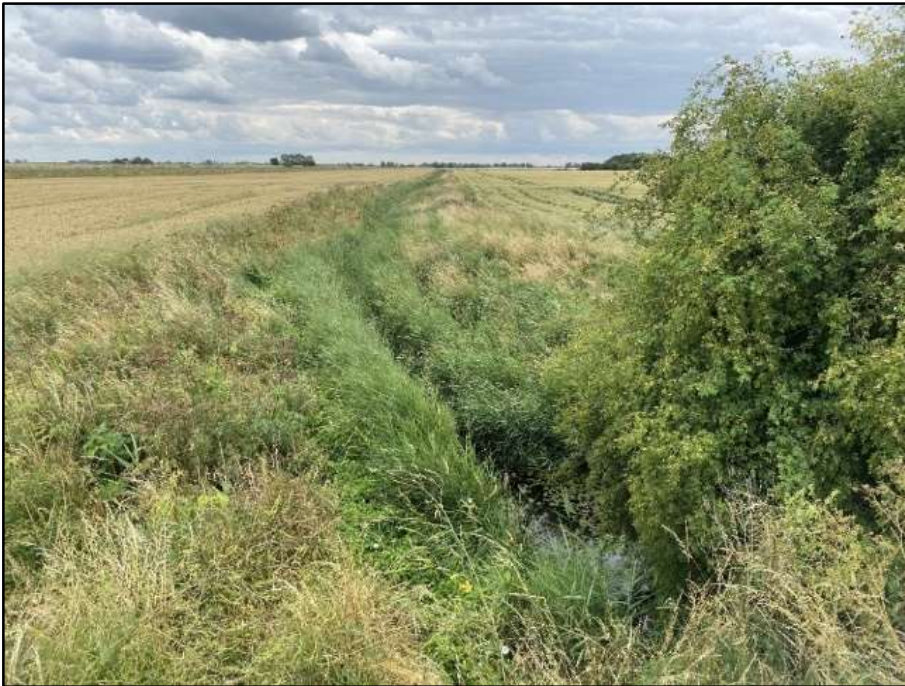
**Location:** 15

**Description:** Unnamed drain, with overgrown vegetation throughout channel, left bank c.1.5m, right bank c.1.5m, width c.2m, Channel c.0.3m no visible flow, no passing place. Facing south.

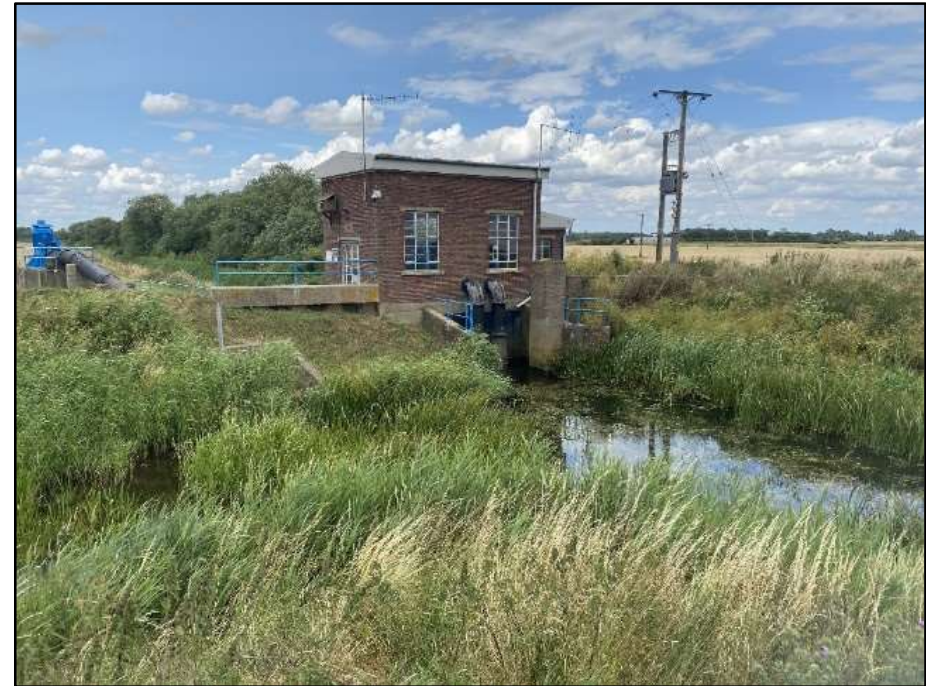
**Location:** 16

**Description:** Pumping station at Hodge Dike, with overgrown vegetation throughout channel, left bank c.1.5m, right bank c.1.5m, width c.2m, channel c.0.3m, no visible flow. Facing northeast.

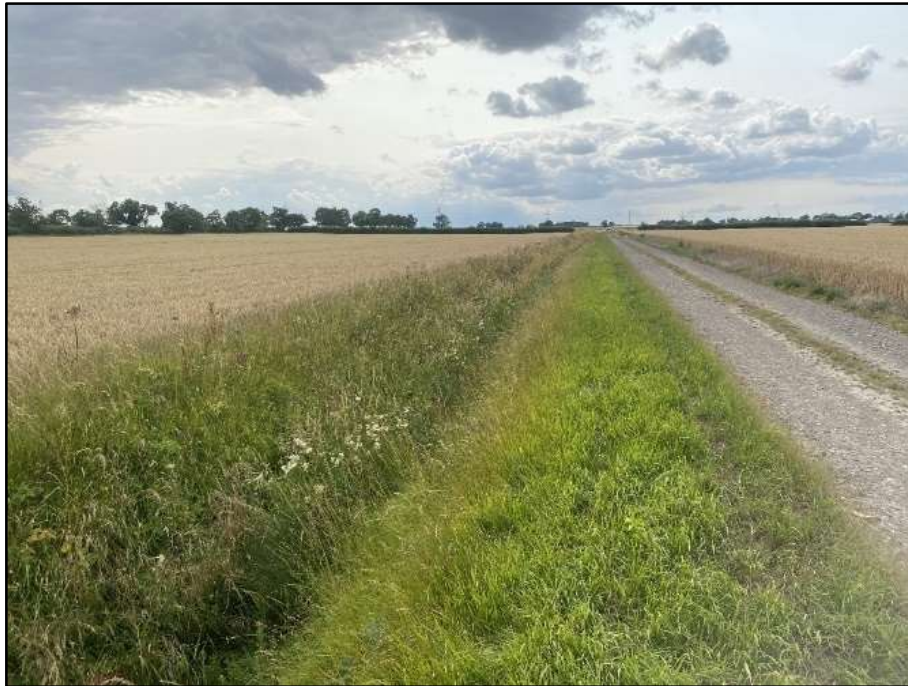
**Location:** 17

**Description:** Unnamed drain, with overgrown vegetation throughout channel, left bank c.1.5m, right bank c.1.5m, width c.2m. Facing west.

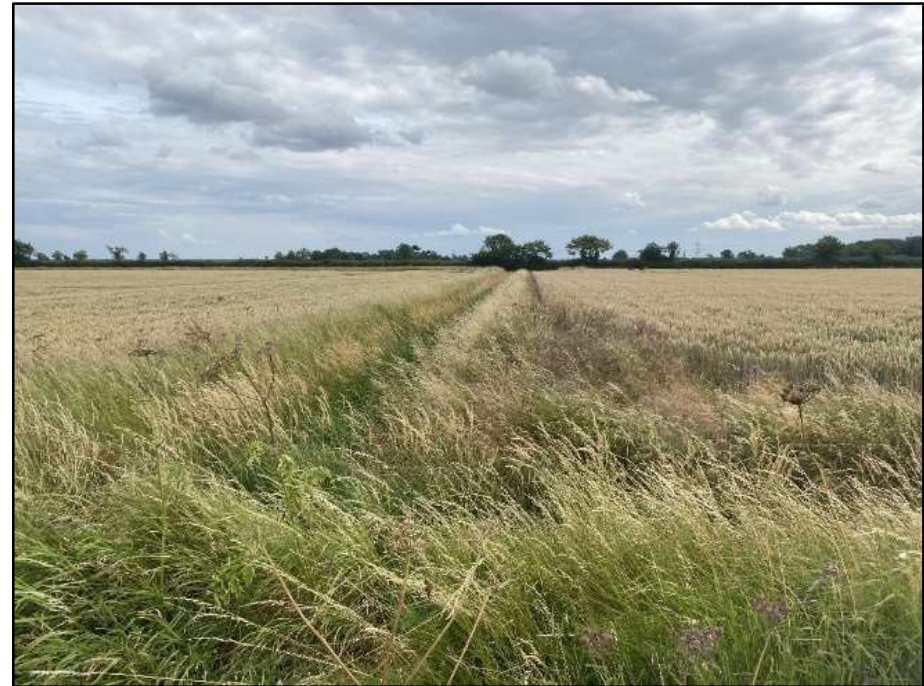
**Location:** 18

**Description:** Unnamed drain, with overgrown vegetation throughout channel, left bank c.1.5m, right bank c.1.5m, width c.2m. Facing south.

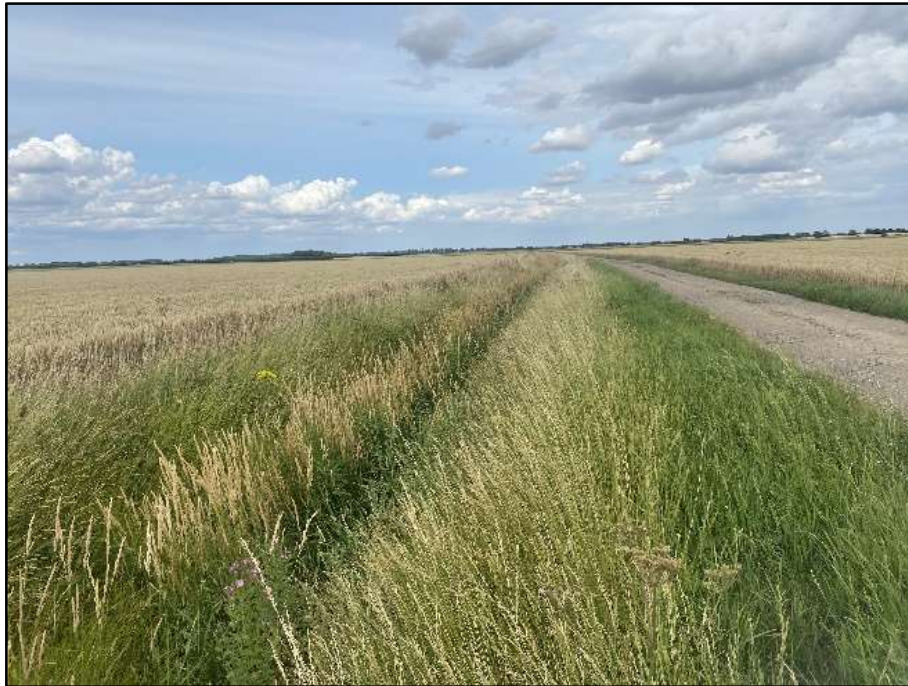
**Location:** 19

**Description:** Unnamed drain, with overgrown vegetation throughout channel, left bank c.1.5m, right bank c.1.5m, width c.2m. Facing east.

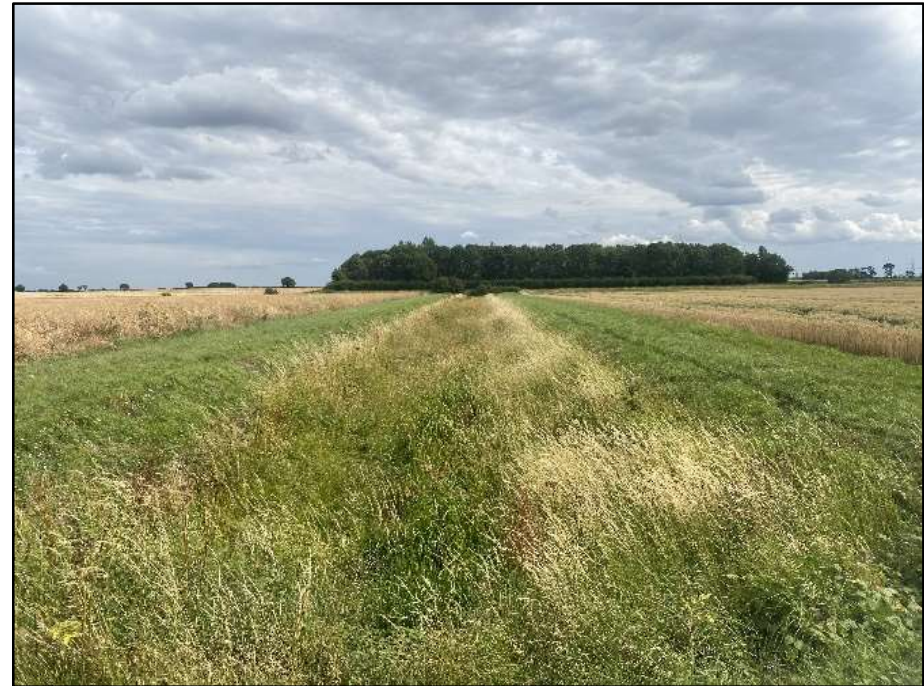
**Location:** 20

**Description:** Unnamed drain, connecting to Hodge Dike by the reservoir, with overgrown vegetation throughout channel, left bank c.1.5m, right bank c.1.5m, width c.3m. facing south.

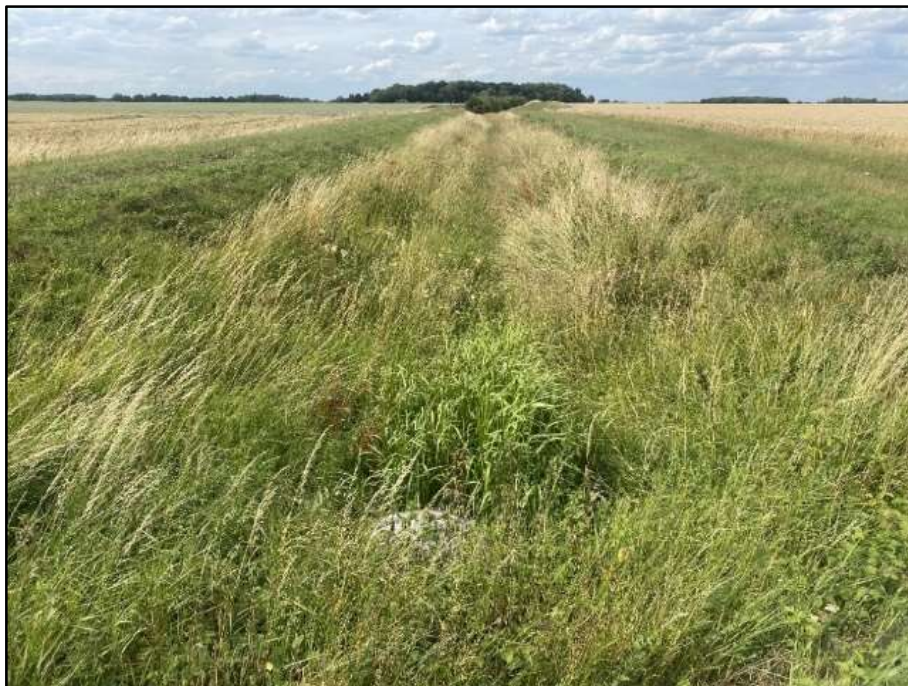
**Location:** 21  
**NGR:** TF 14294 47454

**Description:** Unnamed drain, with overgrown vegetation throughout channel, left bank c.1.5m, right bank c.1.5m, width c.3m. Facing north.

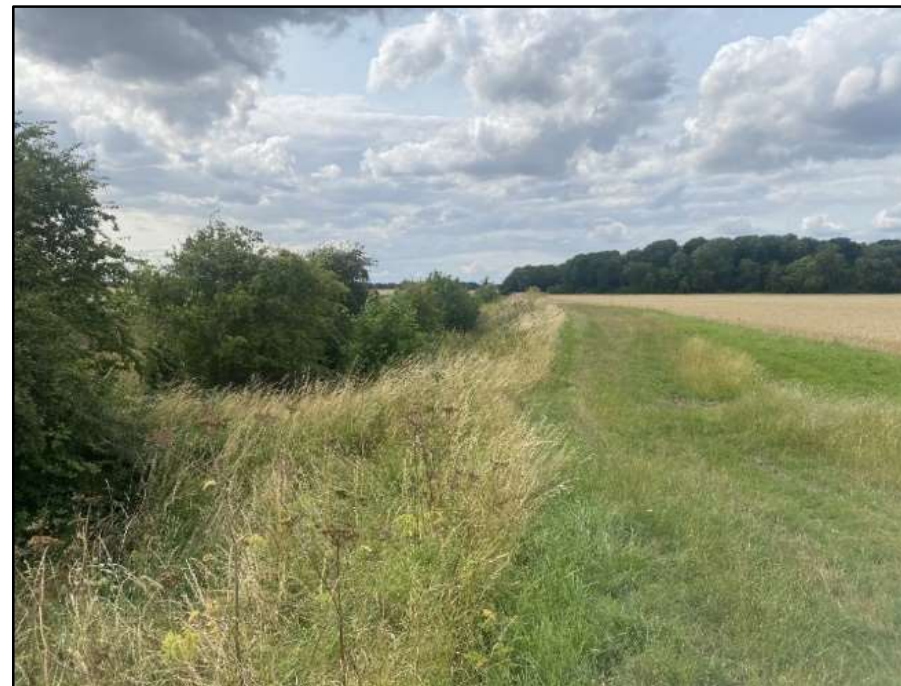
**Location:** 22  
**NGR:** TF 14171 47886

**Description:** Passing place over unnamed drain, with overgrown vegetation throughout channel, left bank c.1.5m, right bank c.1.5m, width c.3m. Facing north.

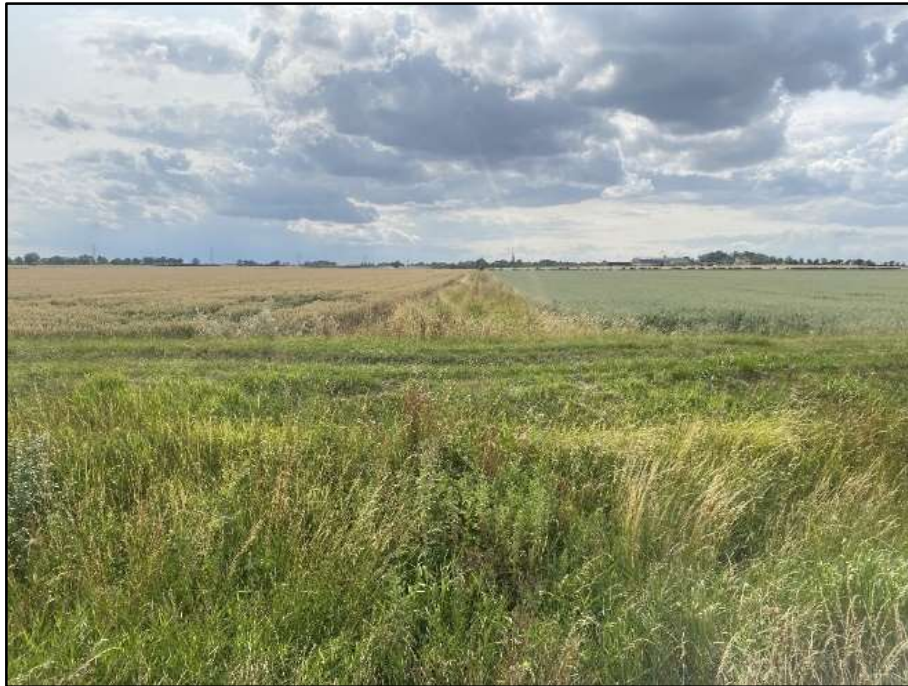
**Location:** 23  
**NGR:** TF 14267 47521

**Description:** Unnamed drain, with overgrown vegetation throughout channel, left bank c.1.5m, right bank c.1.5m, width c.2m. Facing west.

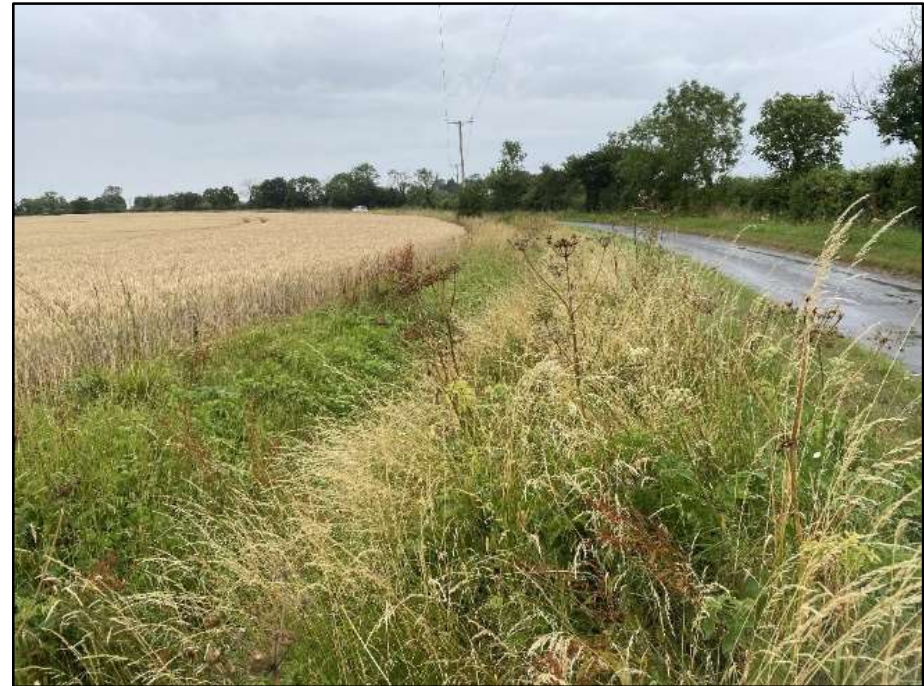
**Location:** 24  
**NGR:** TF 13657 48344

**Description:** unnamed drain, with overgrown vegetation throughout channel, left bank c.1m, right bank c.1m, width c.2m. Facing west.

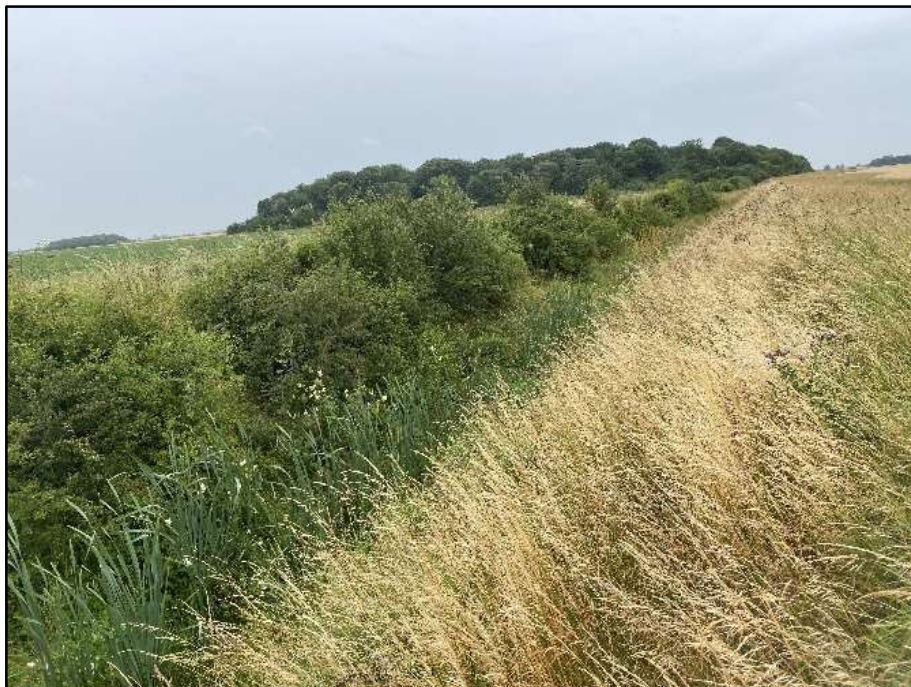
**Location:** 25

**Description:** Unnamed drain, with hedge and overgrown vegetation throughout channel, left bank c.1.5m, right bank c.1.5m, width c.2m. Facing southeast.

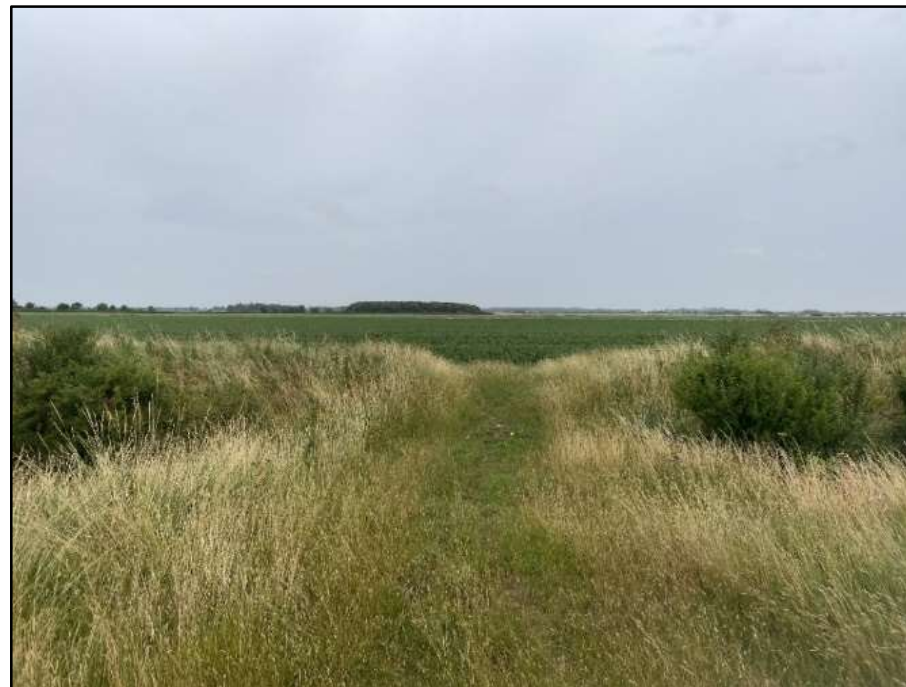
**Location:** 26

**Description:** Passing place over unnamed drain, width c.3m. Facing east.

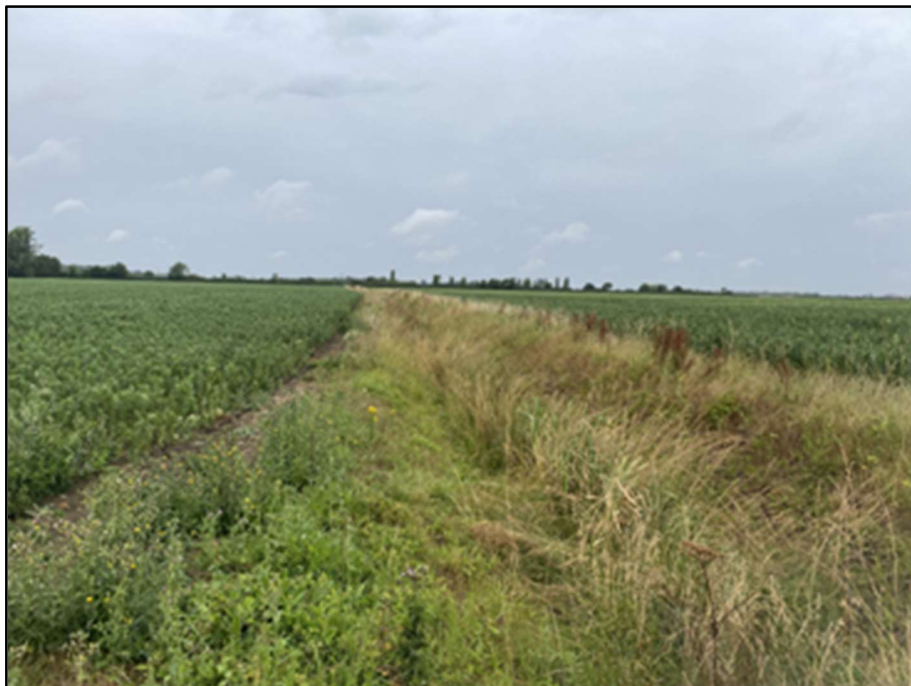
**Location:** 27  
**NGR:** TF 14140 48279  
**Photo Date:** 14 July 2023  
**Description:** Unnamed drain, with hedge and overgrown vegetation throughout channel, left bank c.1.5m, right bank c.1.5m, width c.2m. Facing east.

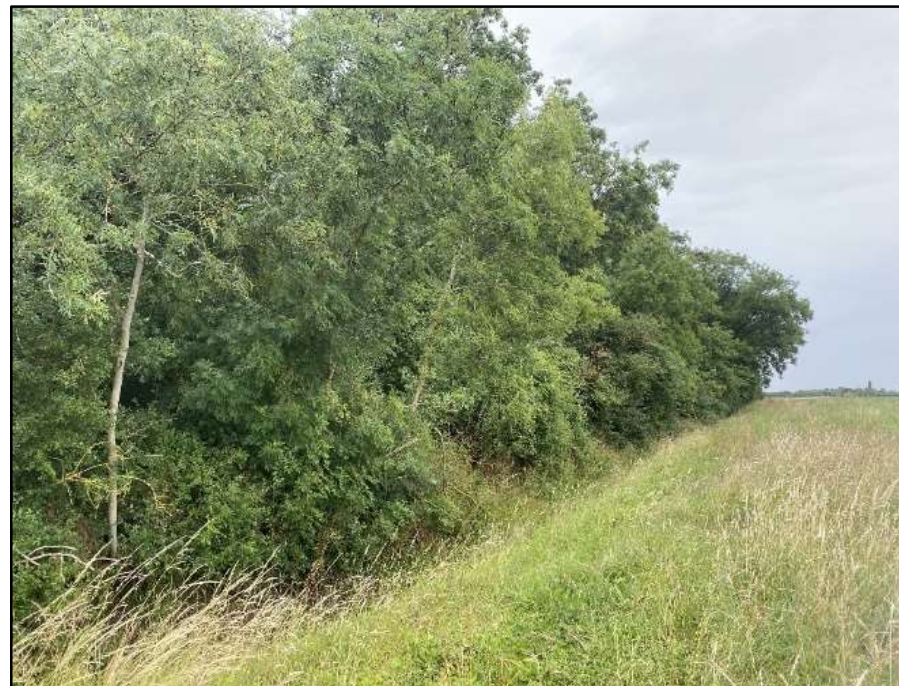
**Location:** 28  
**NGR:** TF 14133 48209  
**Photo Date:** 14 July 2023  
**Description:** Unnamed drain, with hedge and overgrown vegetation throughout channel, left bank c.1.5m, right bank c.1.5m, width c.2m. Facing north.

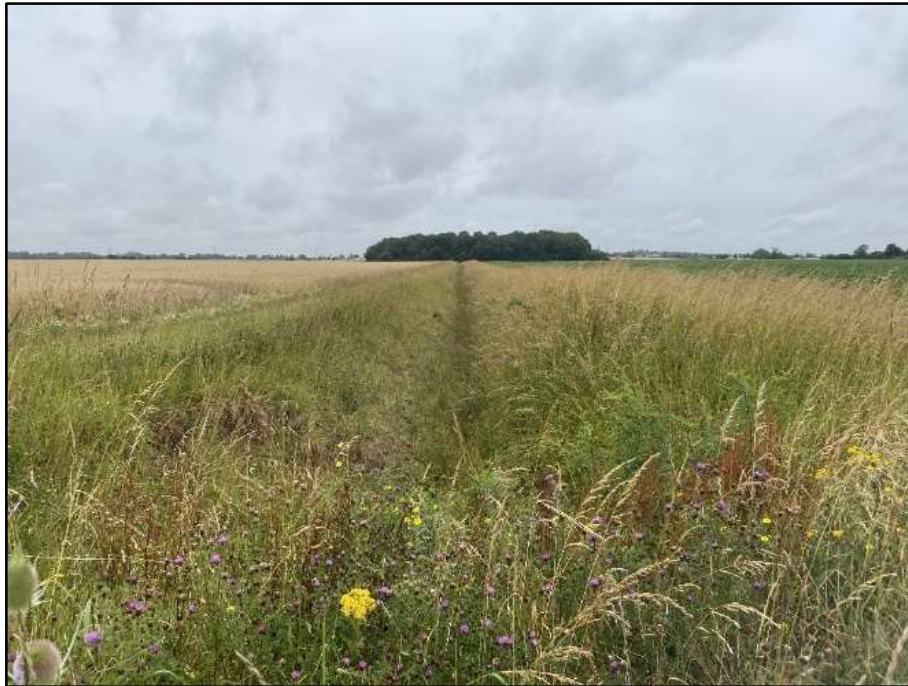
**Location:** 29  
**NGR:** TF 14481 48557  
**Photo Date:** 14 July 2023  
**Description:** Passing place over unnamed drain, width c.3m. Facing west.

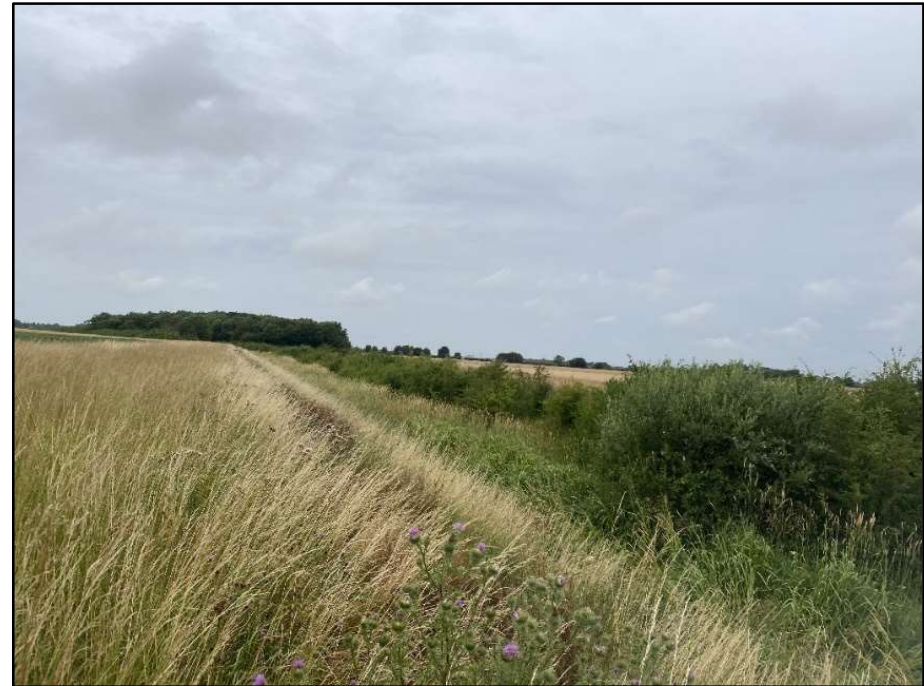
**Location:** 30  
**NGR:** TF 14481 48557  
**Photo Date:** 14 July 2023  
**Description:** Unnamed drain, with hedge and overgrown vegetation throughout channel, left bank c.1.5m, right bank c.1.5m, width c.4m. Facing north.

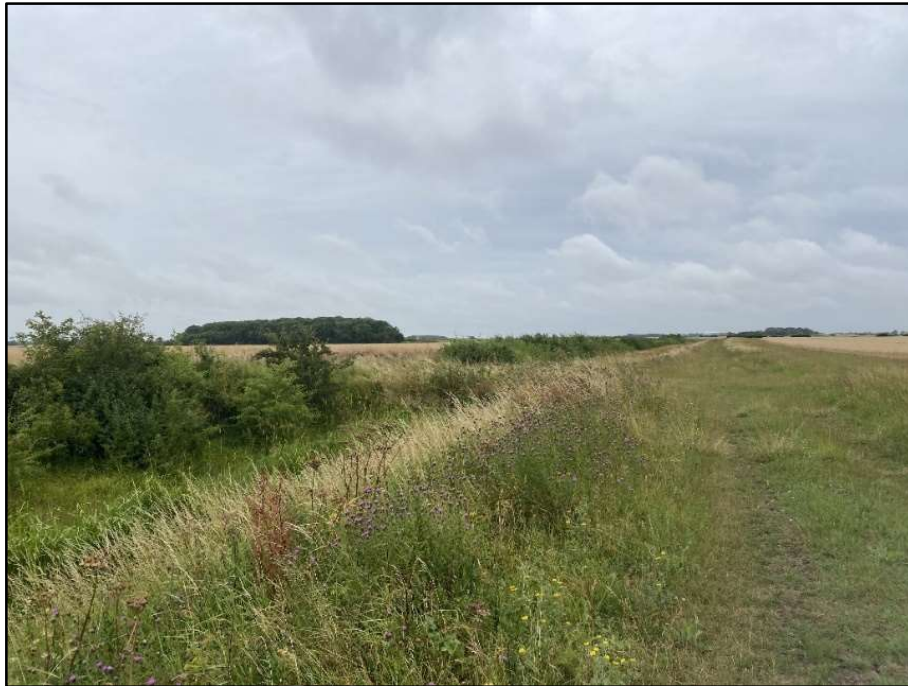
**Location:** 31  
**NGR:** TF 14539 48488  
**Photo Date:** 14 July 2023  
**Description:** Passing place and unnamed drain, with hedge and overgrown vegetation throughout channel, left bank c.1.5m, right bank c.1.5m, width c.4m. Facing southeast.

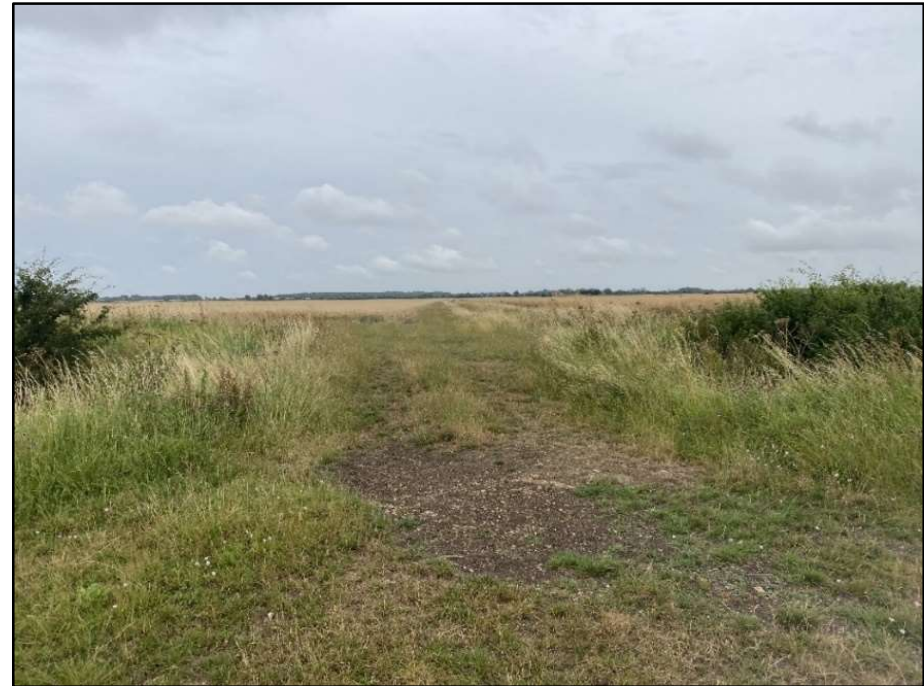
**Location:** 32  
**NGR:** TF 14548 48477  
**Photo Date:** 14 July 2023  
**Description:** Passing place. Facing northwest.

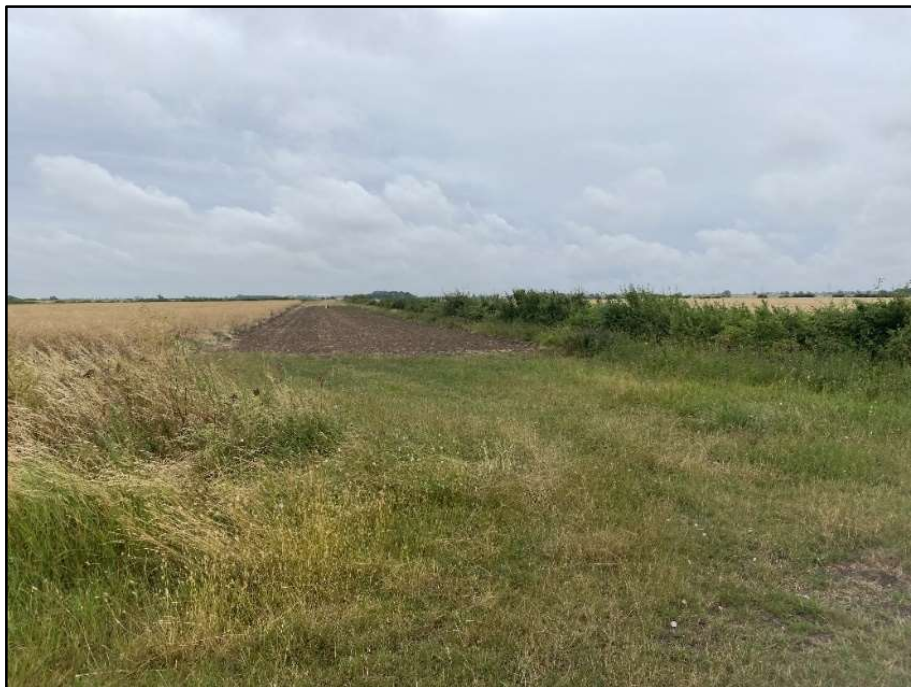
**Location:** 33  
**NGR:** TF 14567 48495  
**Photo Date:** 14 July 2023  
**Description:** Passing place. Facing southeast.

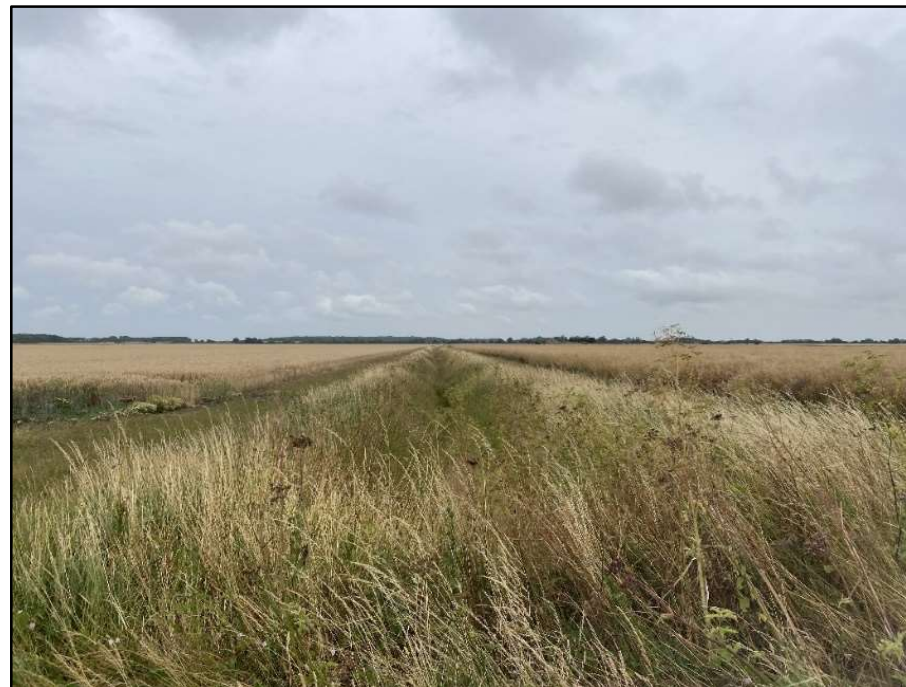
**Location:** 34  
**NGR:** TF 14481 48557  
**Photo Date:** 14 July 2023  
**Description:** Unnamed drain, with hedge and overgrown vegetation throughout channel, left bank c.1.5m, right bank c.1.5m, width c.4m. facing east.

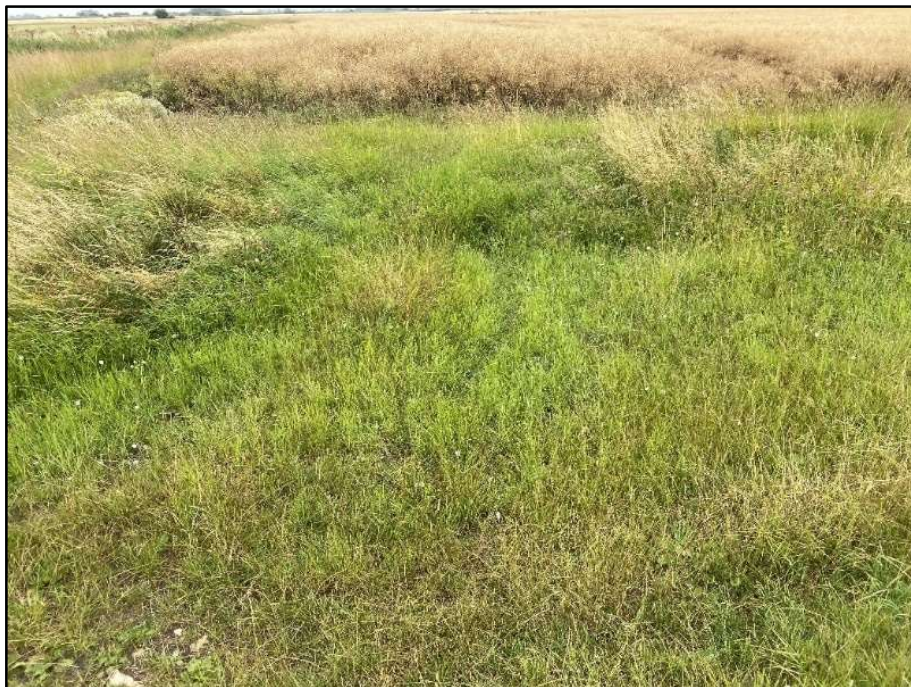
**Location:** 35  
**NGR:** TF 15050 48856  
**Photo Date:** 14 July 2023  
**Description:** Passing place. Facing south.
