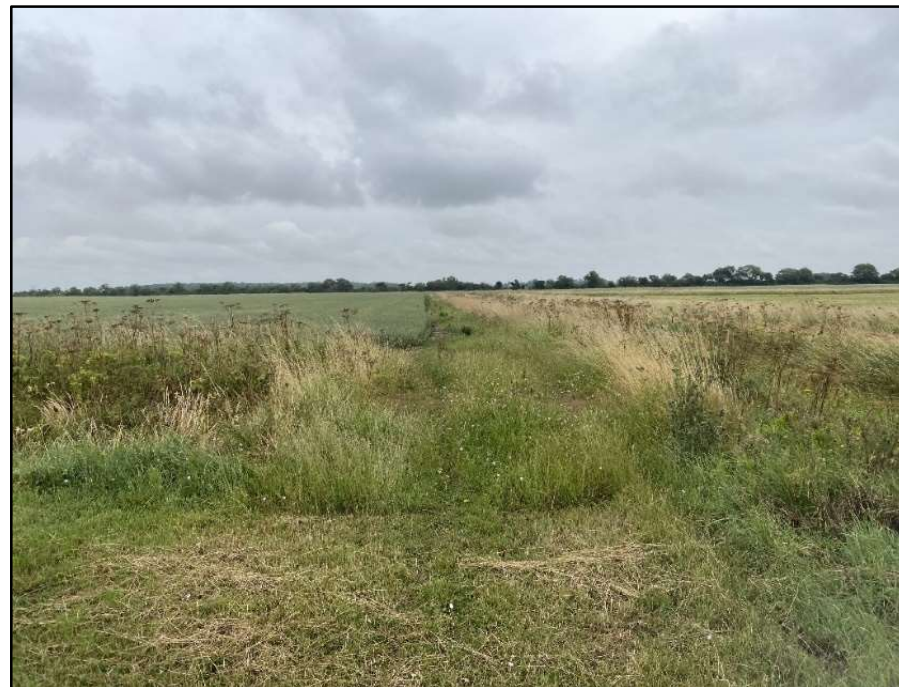
**Location:** 36  
**NGR:** TF 15218 48969  
**Photo Date:** 14 July 2023  
**Description:** Passing place adjacent to unnamed drain, with overgrown vegetation throughout channel, left bank c.1.5m, right bank c.1.5m, width c.3m. Facing east.

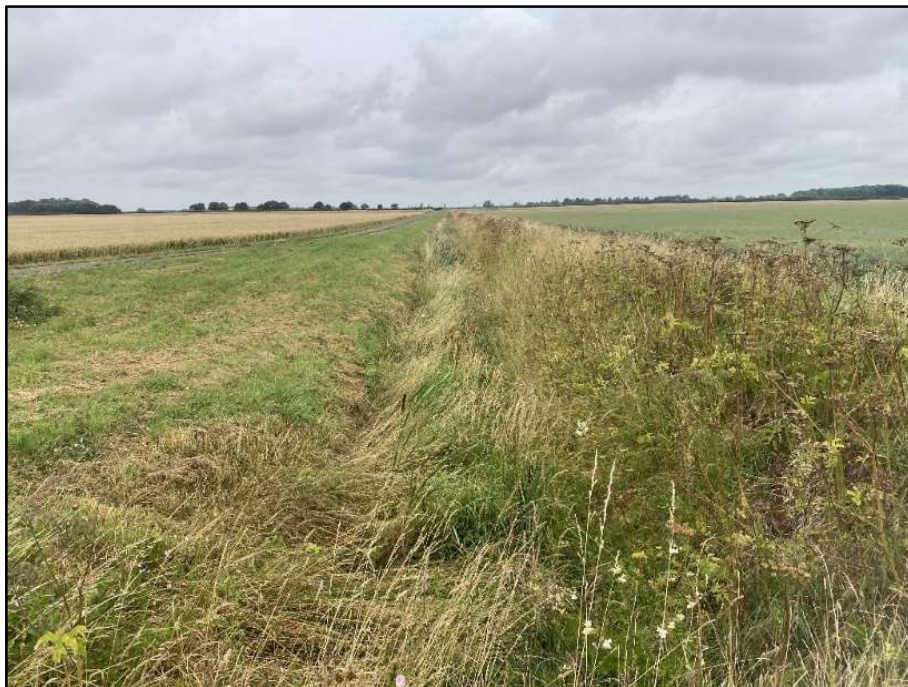
**Location:** 37  
**NGR:** TF 15218 48969  
**Photo Date:** 14 July 2023  
**Description:** Passing place and unnamed drain, with hedge and overgrown vegetation throughout channel, left bank c.1.5m, right bank c.1.5m, width c.2m. Facing north.

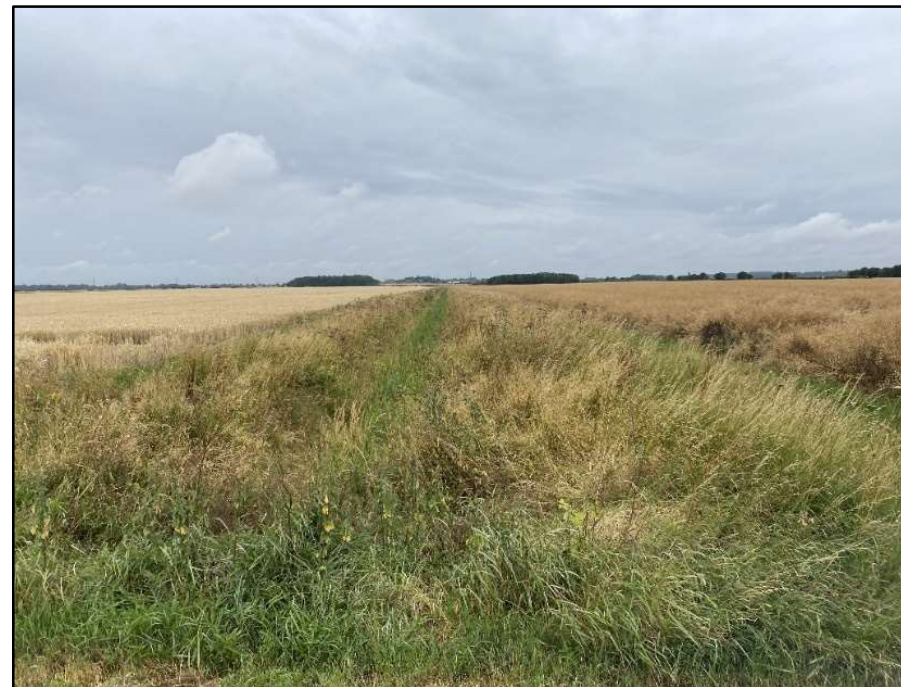
**Location:** 38  
**NGR:** TF 15149 49098  
**Photo Date:** 14 July 2023  
**Description:** Unnamed drain, with overgrown vegetation throughout channel, left bank c.1.5m, right bank c.1.5m, width c.4m. Facing west.

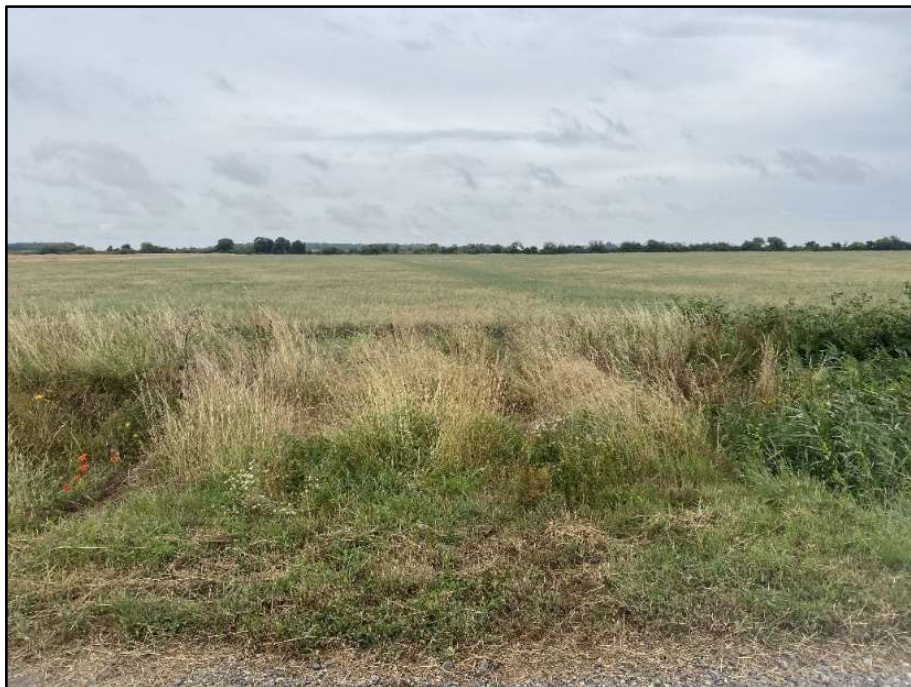
**Location:** 39  
**NGR:** TF 15070 49249  
**Photo Date:** 14 July 2023  
**Description:** Passing place, width c.3m. Facing northeast.

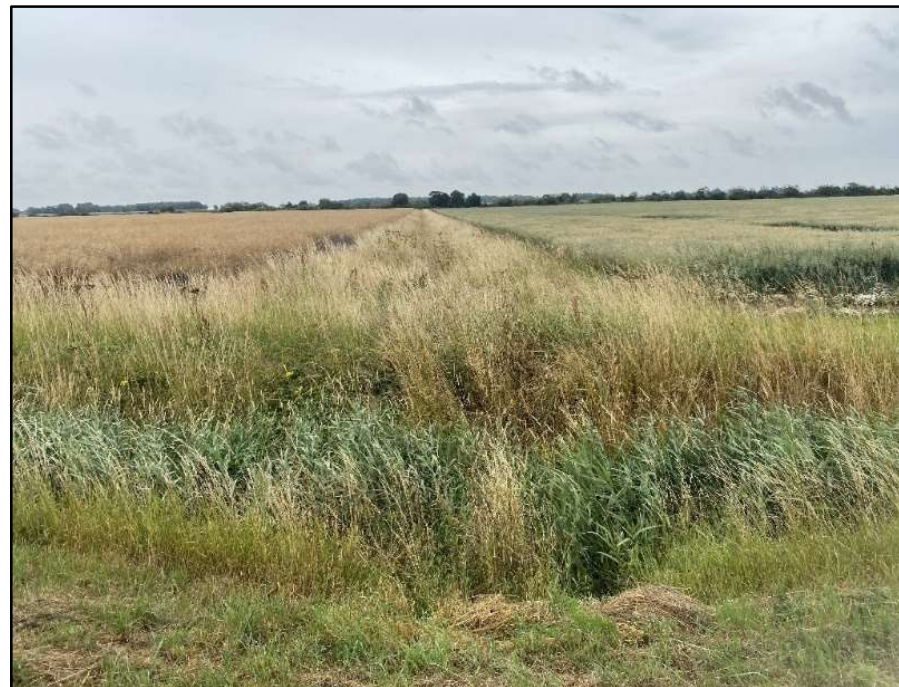
**Location:** 40  
**NGR:** TF 15041 49314  
**Photo Date:** 14 July 2023  
**Description:** Unnamed drain, with overgrown vegetation throughout channel, left bank c.1.5m, right bank c.1.5m, width c.2m. Facing east.

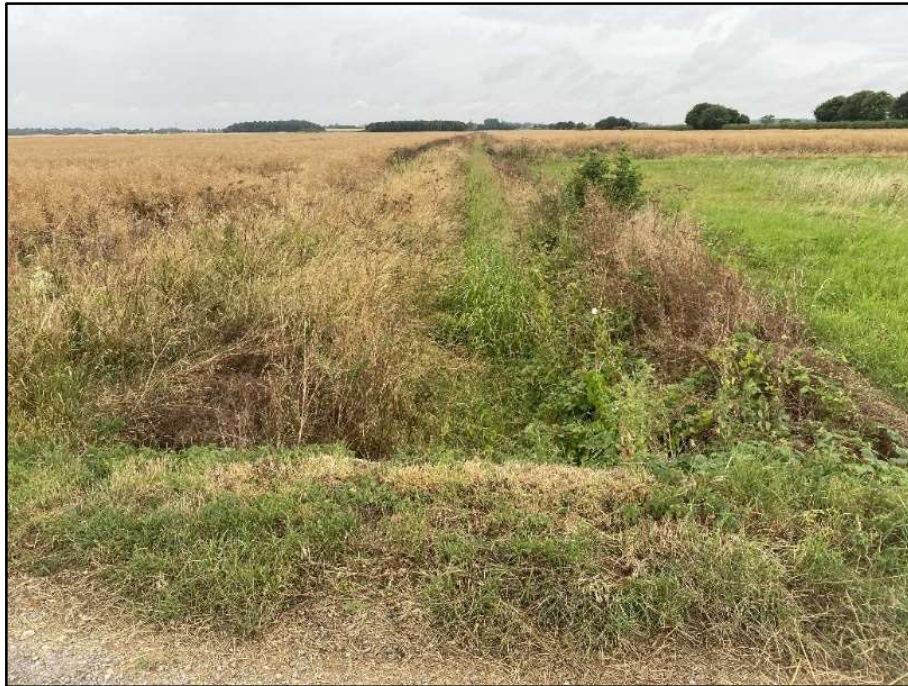
**Location:** 41  
**NGR:** TF 15070 49249  
**Photo Date:** 14 July 2023  
**Description:** Unnamed drain, with overgrown vegetation throughout channel, left bank c.1m, right bank c.1m, width c.3m. Facing west.

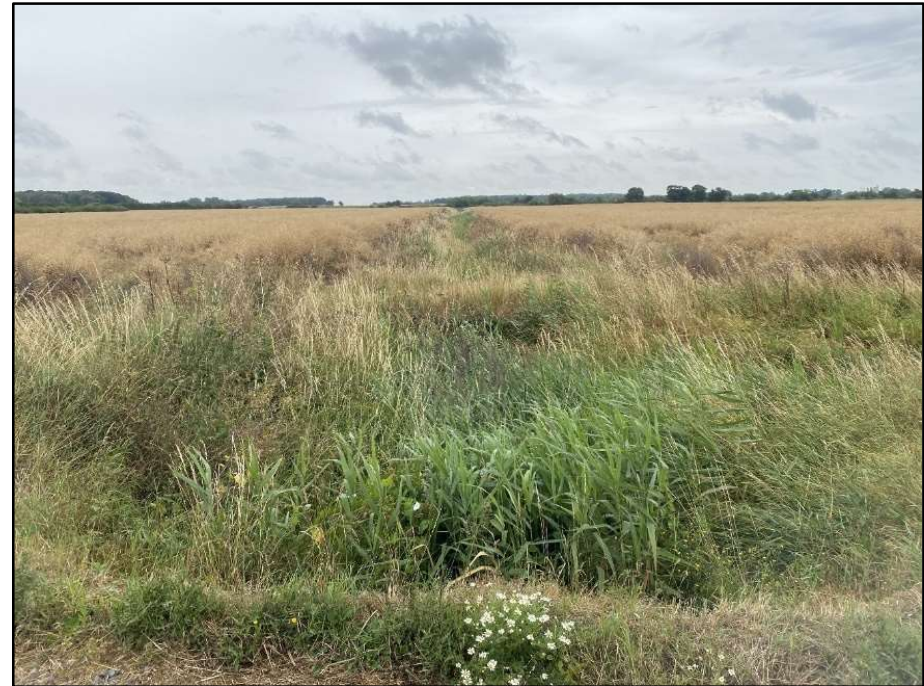
**Location:** 42  
**NGR:** TF 14977 49425  
**Photo Date:** 14 July 2023  
**Description:** Unnamed drain, with overgrown vegetation throughout channel, left bank c.1m, right bank c.1m, width c.3m. Facing east.
